**INSPECTION REPORT: BULK ASBESTOS SURVEY  
SAN YSIDRO BORDER CROSSING  
BUILDING CA0588  
720 E. SAN YSIDRO  
SAN DIEGO, CA 92115**

**GSA Contract No.: GS-09P-07-NQ-M-0023**

**SCA Project No.: G-8452**

**JUNE 2007**

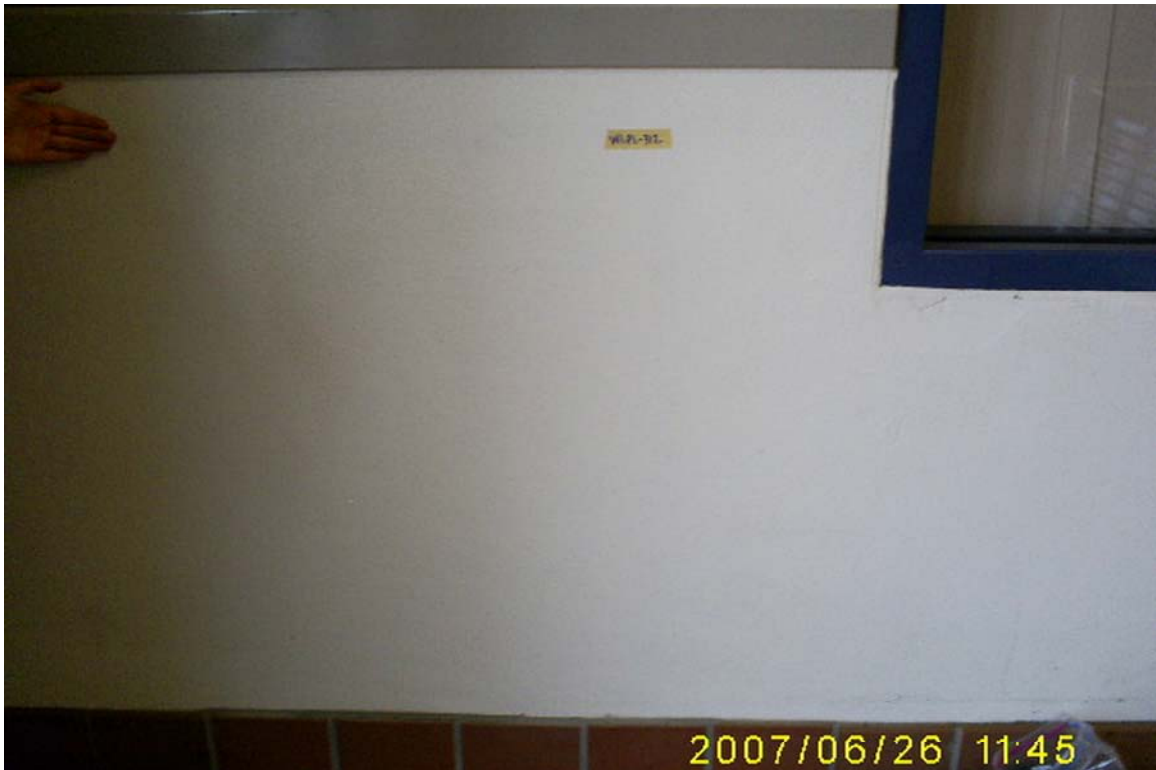
*Below: HA WLPL-312*

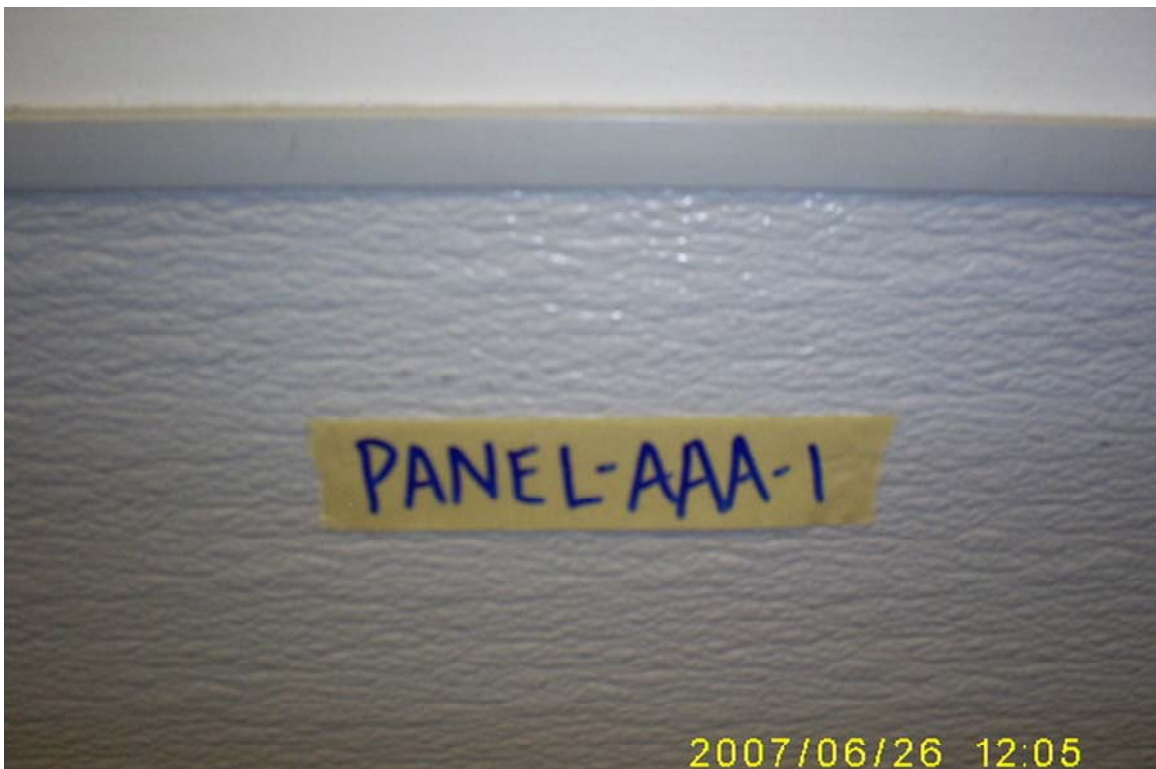
*Above: WLPL-312*

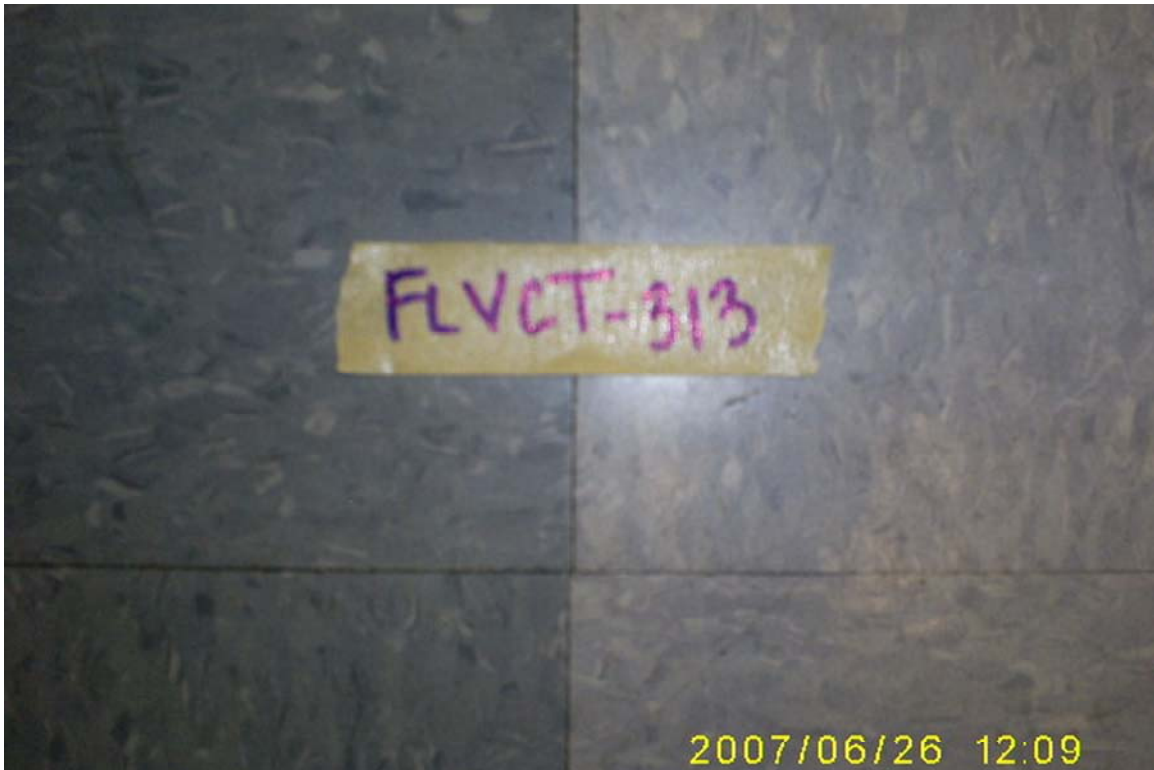
*Below: HA PANEL-AAA1*

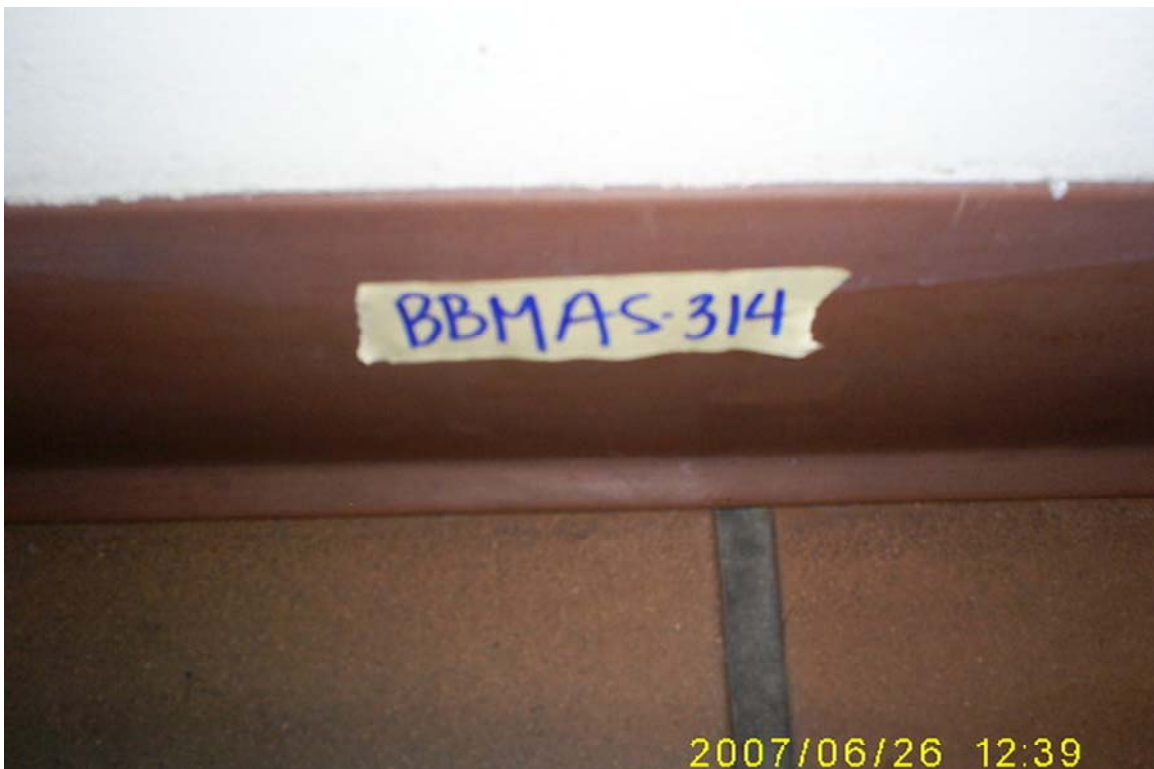
*Above: HA FLVCT-313*

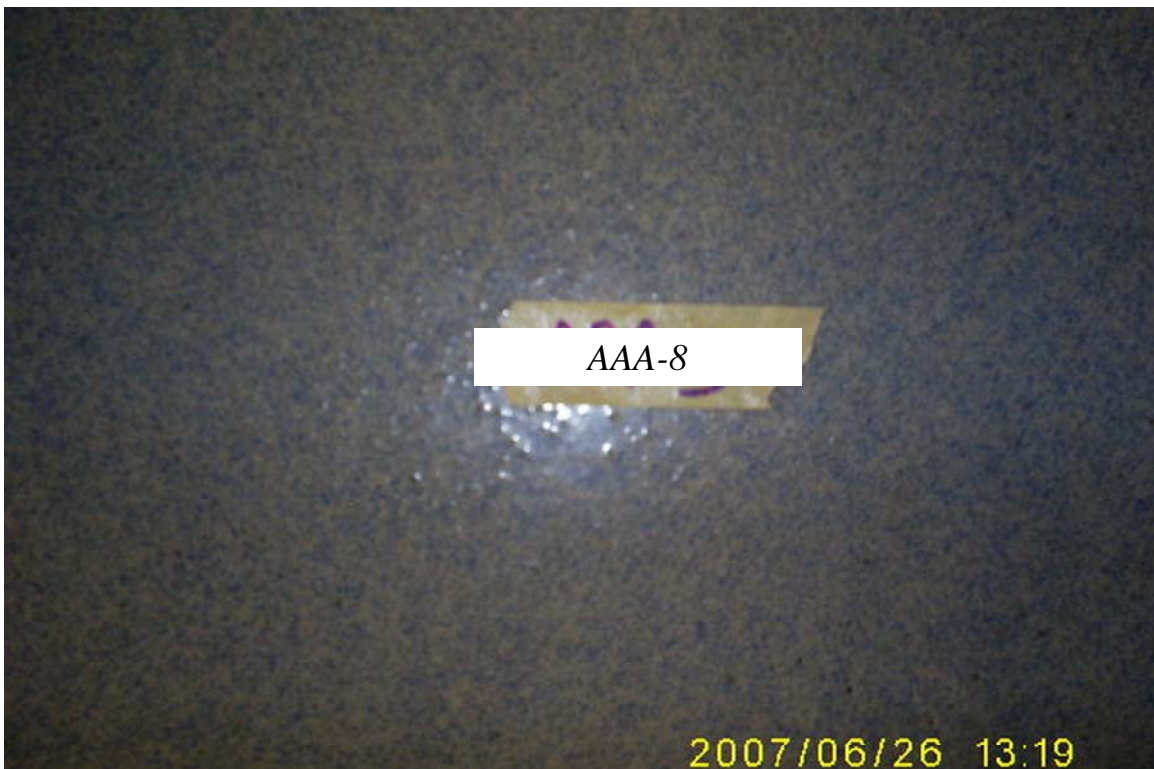
*Above: HA AAA-2*

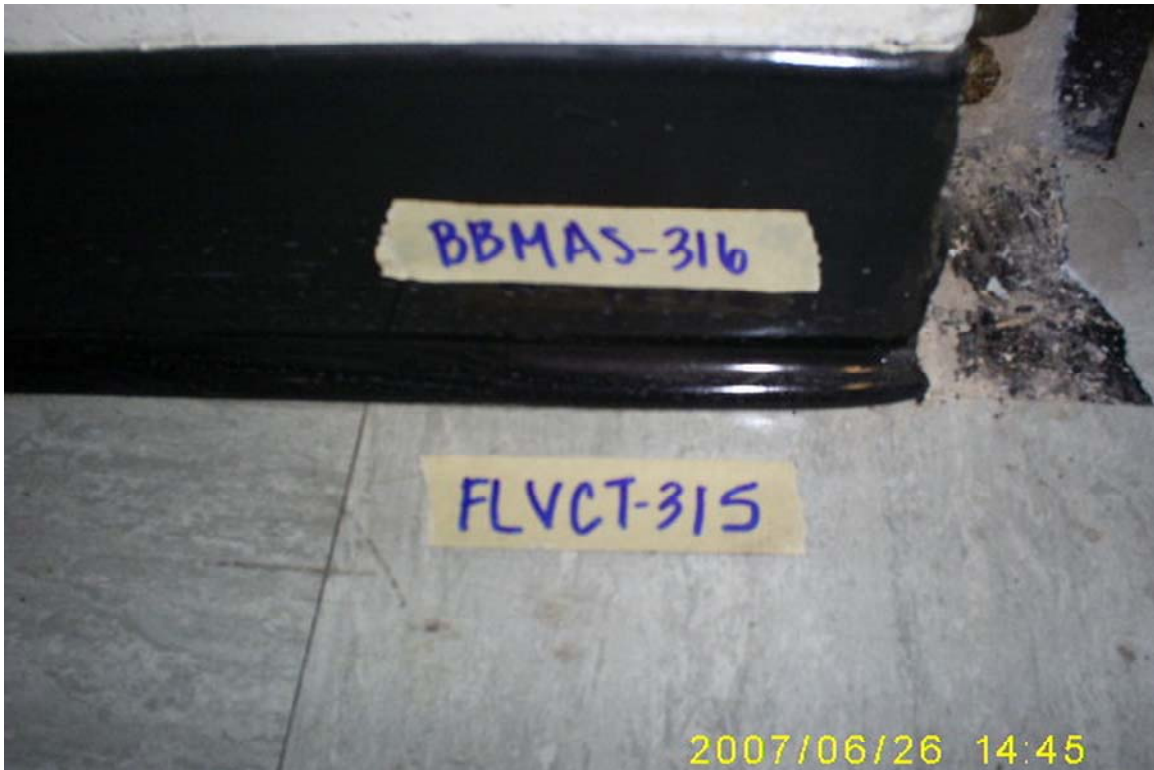
*Below: HA AAA-8*

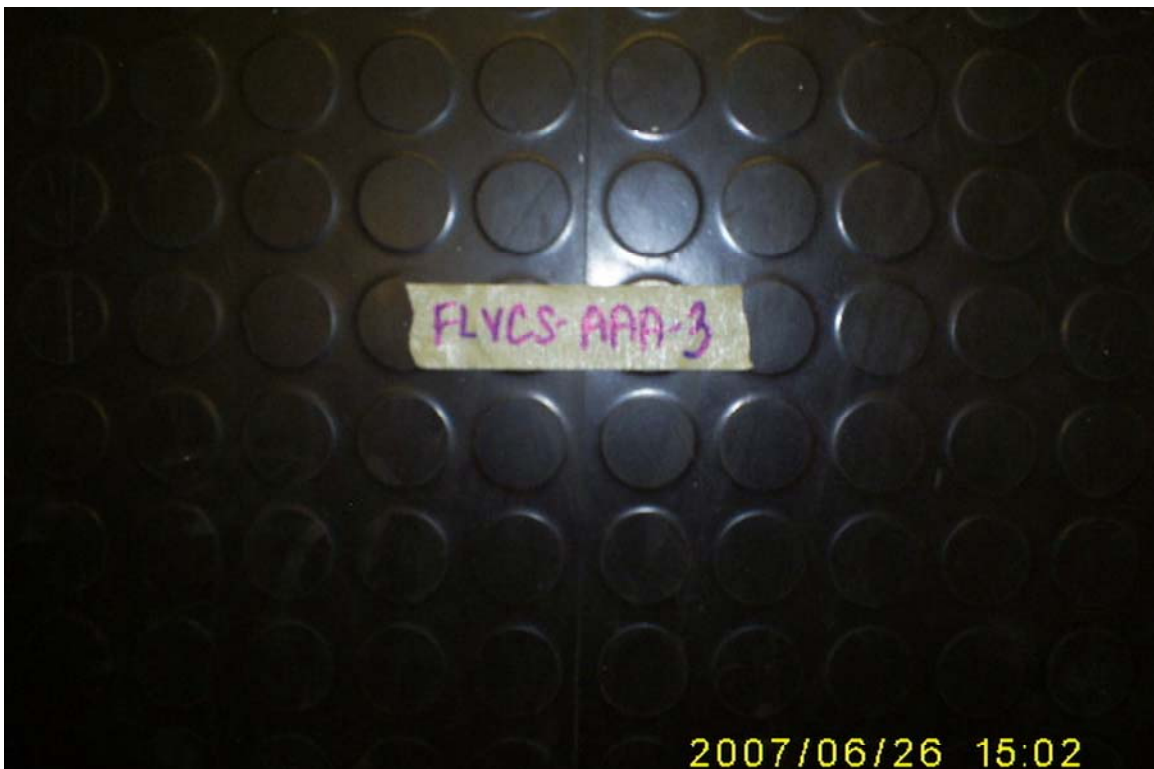
*Above: HA'S BBMAS-316 & FLVCT-315*

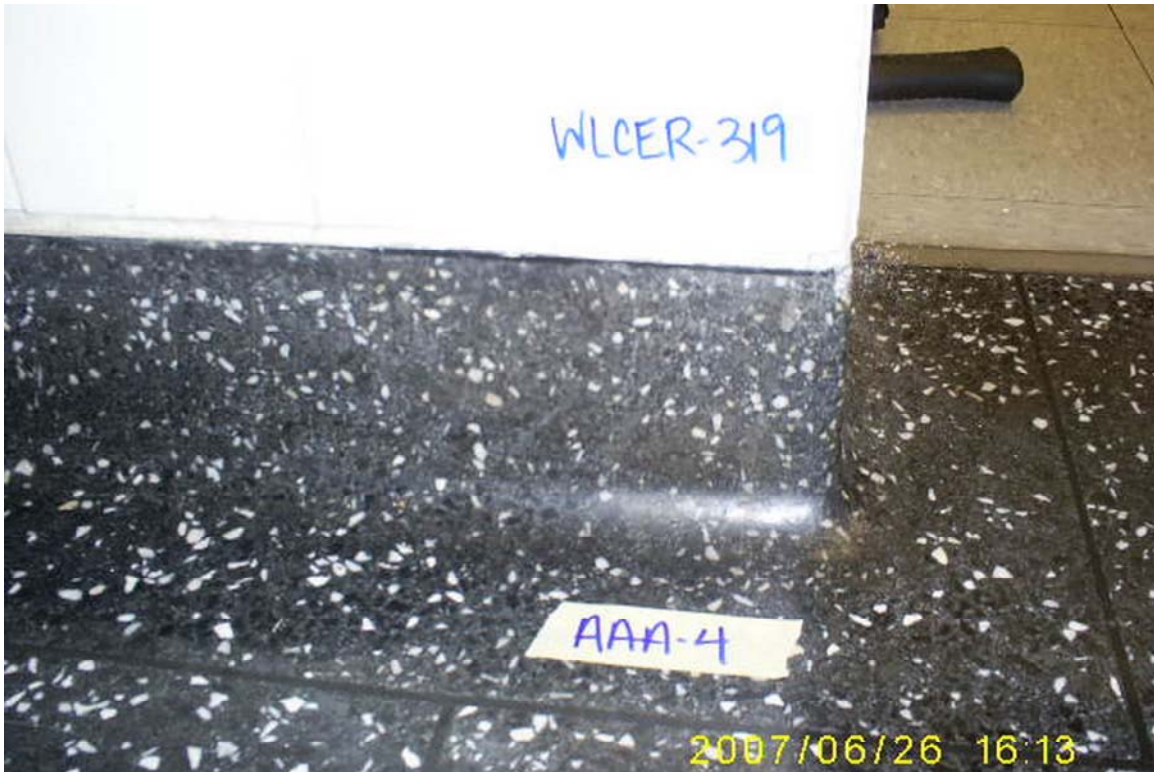
*Below: HA CLPLAC-318*

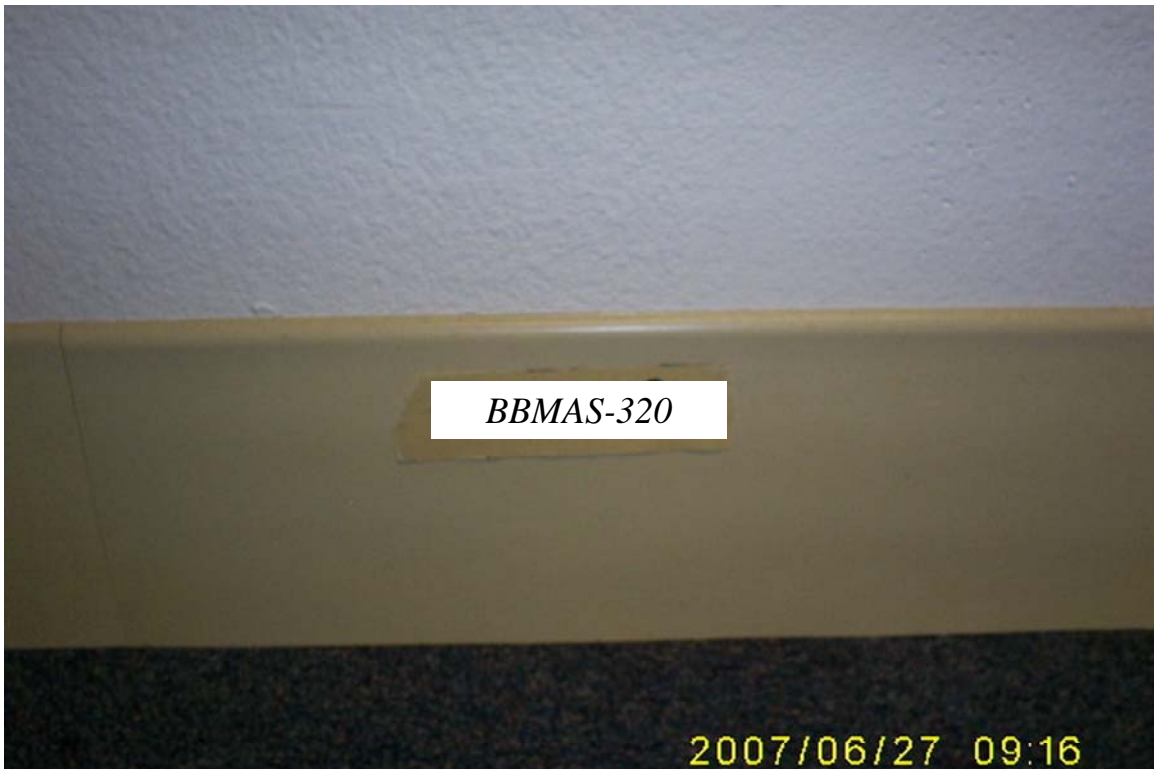
*Above: HA WLCER-319 & AAA-4*

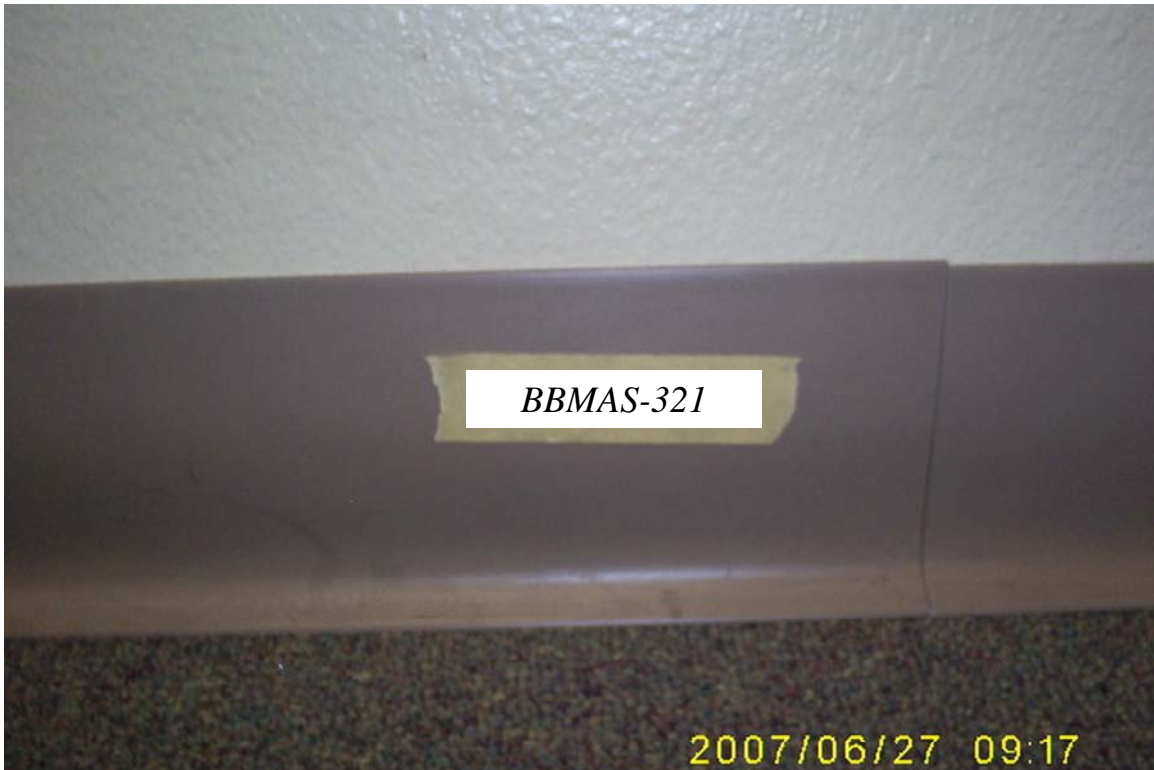
*Below: HA BBMAS-320*

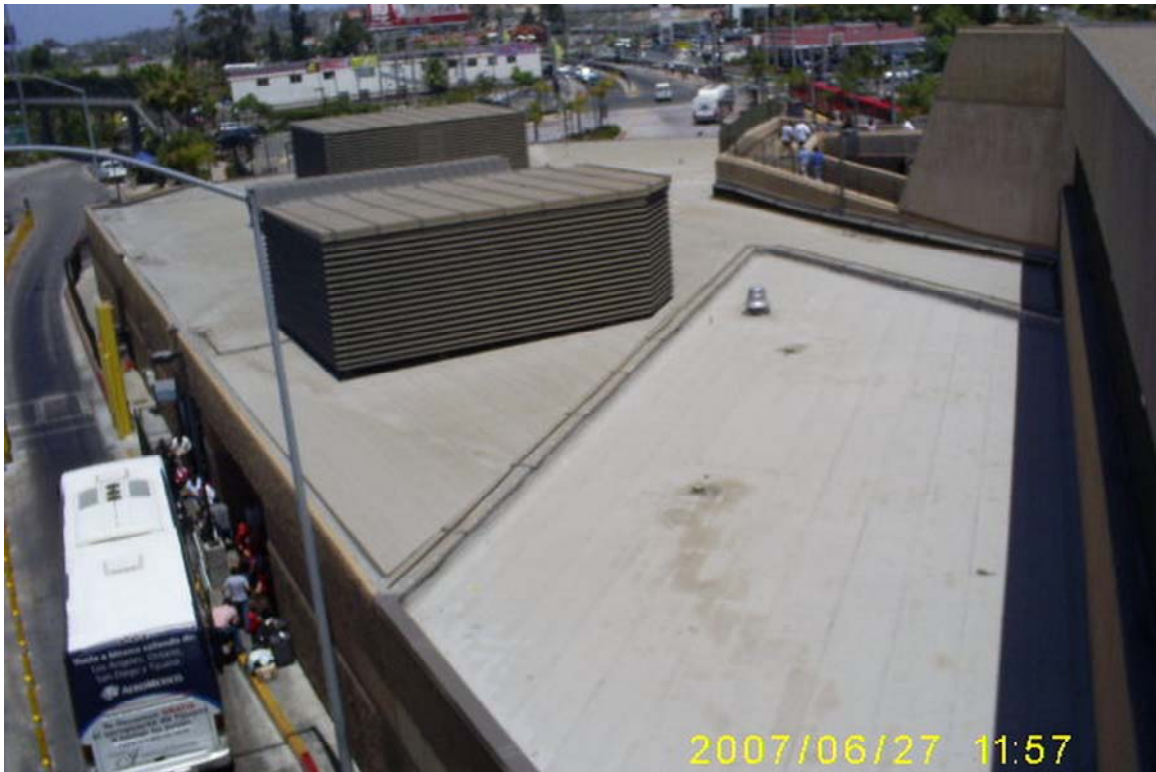
*Below: HA CLPL-322*

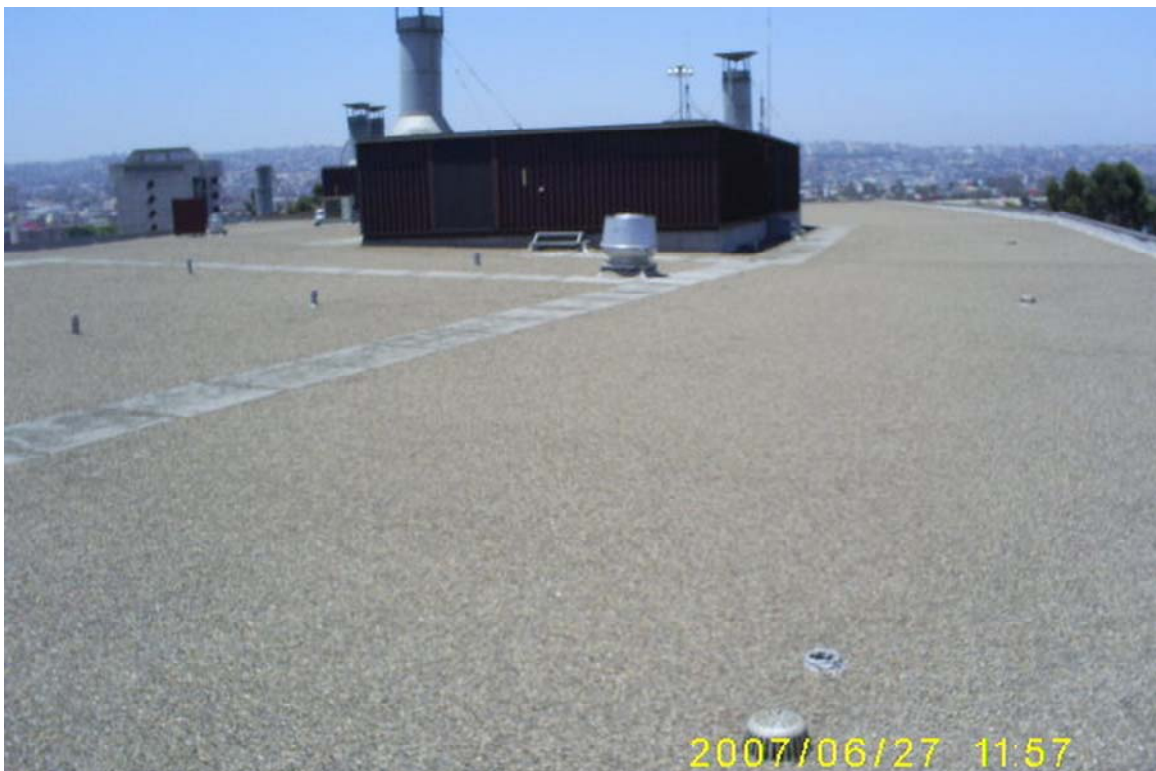
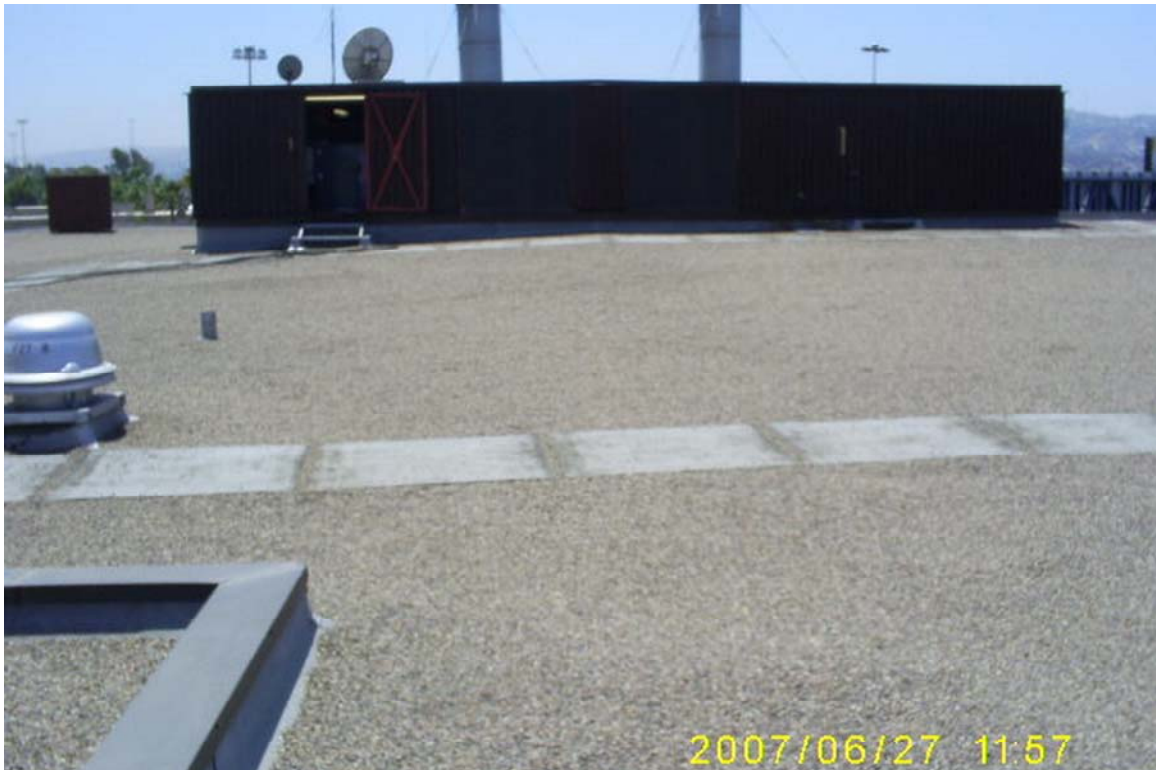
*Above & below: View of roofs, HA-AAA5*

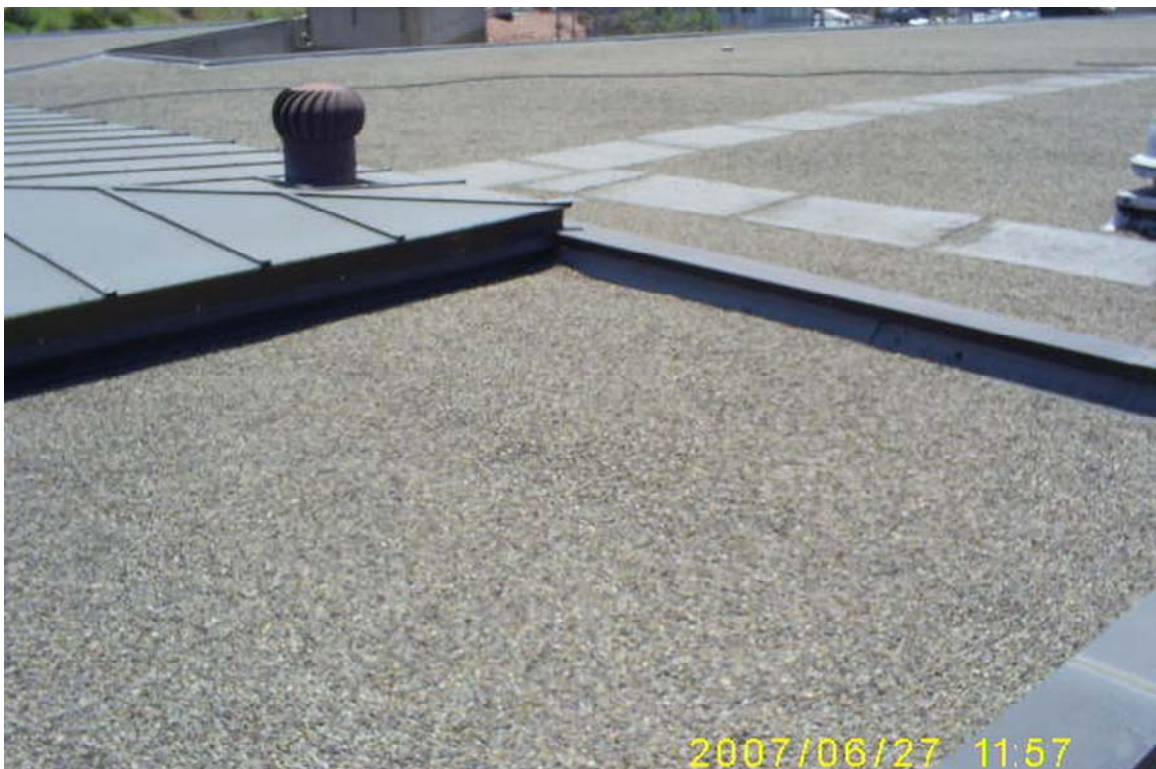
*Above & below: View of roofs, HA-AAA5*

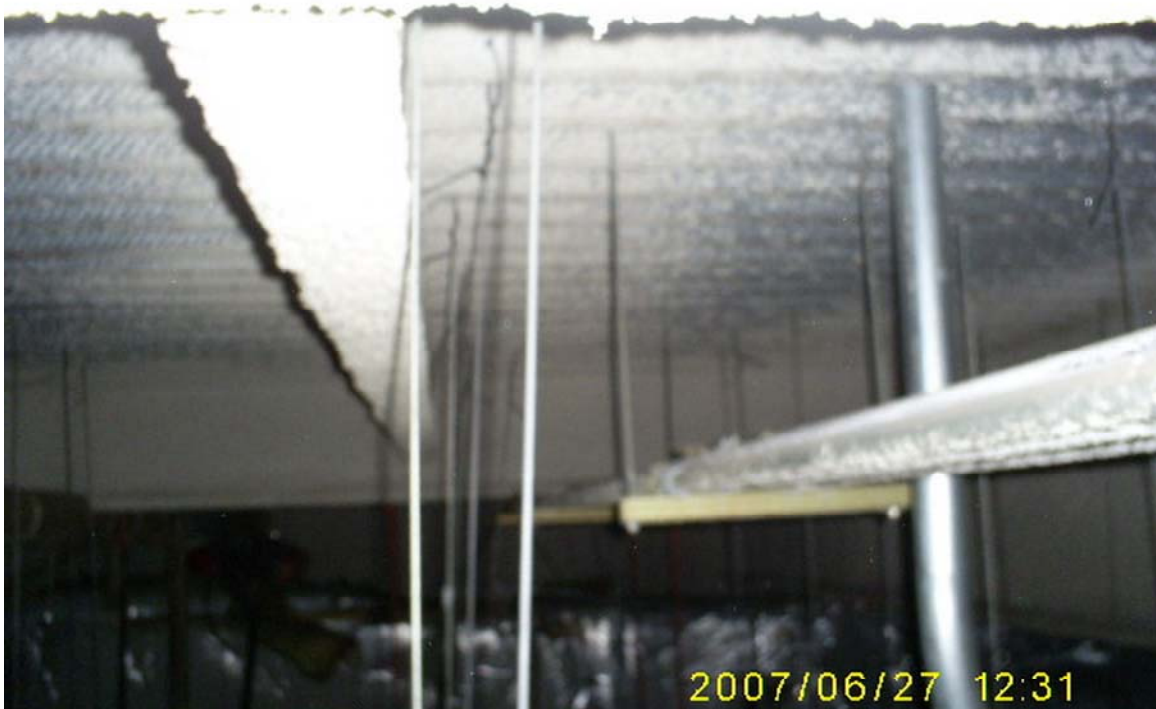
*Above & below: HA STSFP-300*

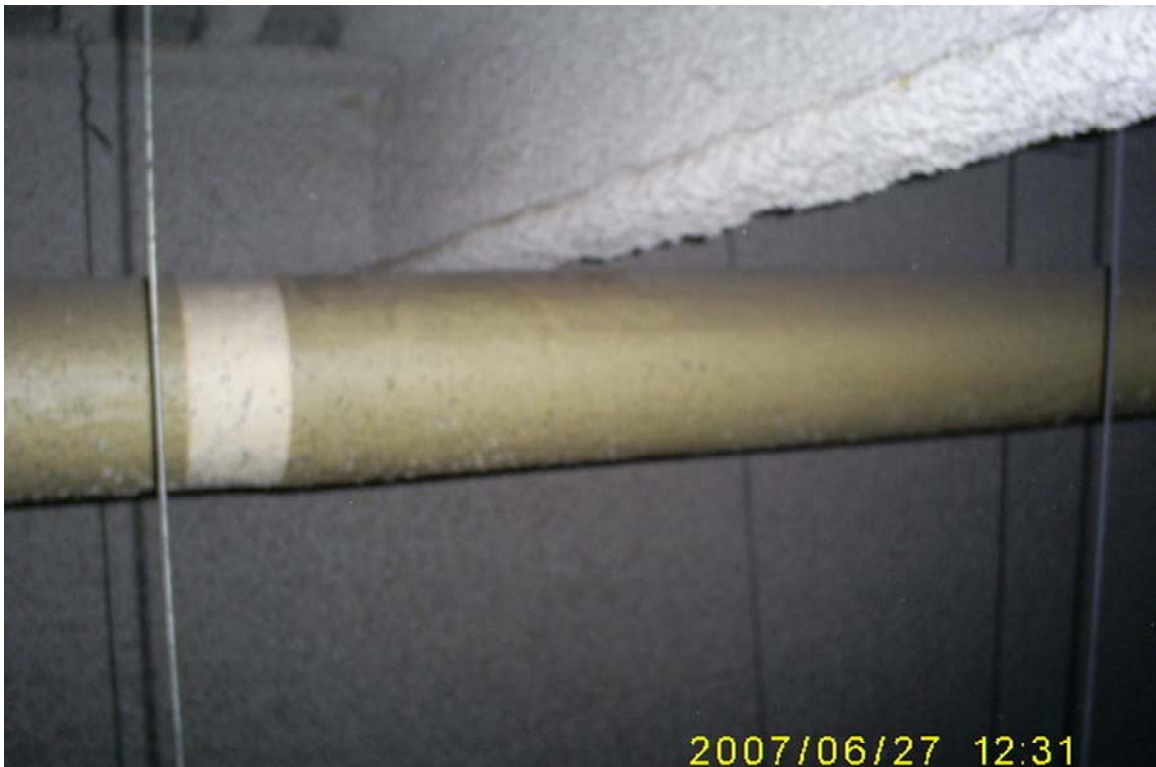
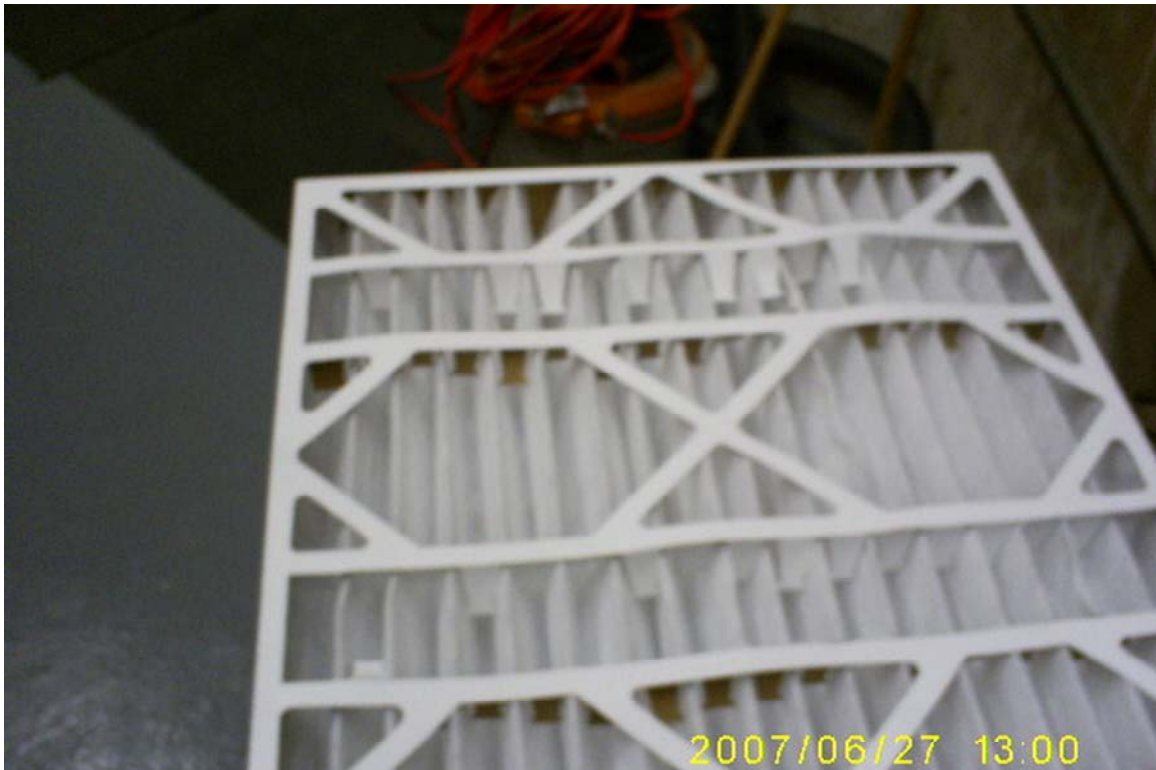
*Above & blow: Main Canopy Soffit;  
HA STSFP-300 & DHWMUD-325 & non-suspect PI-NNN*

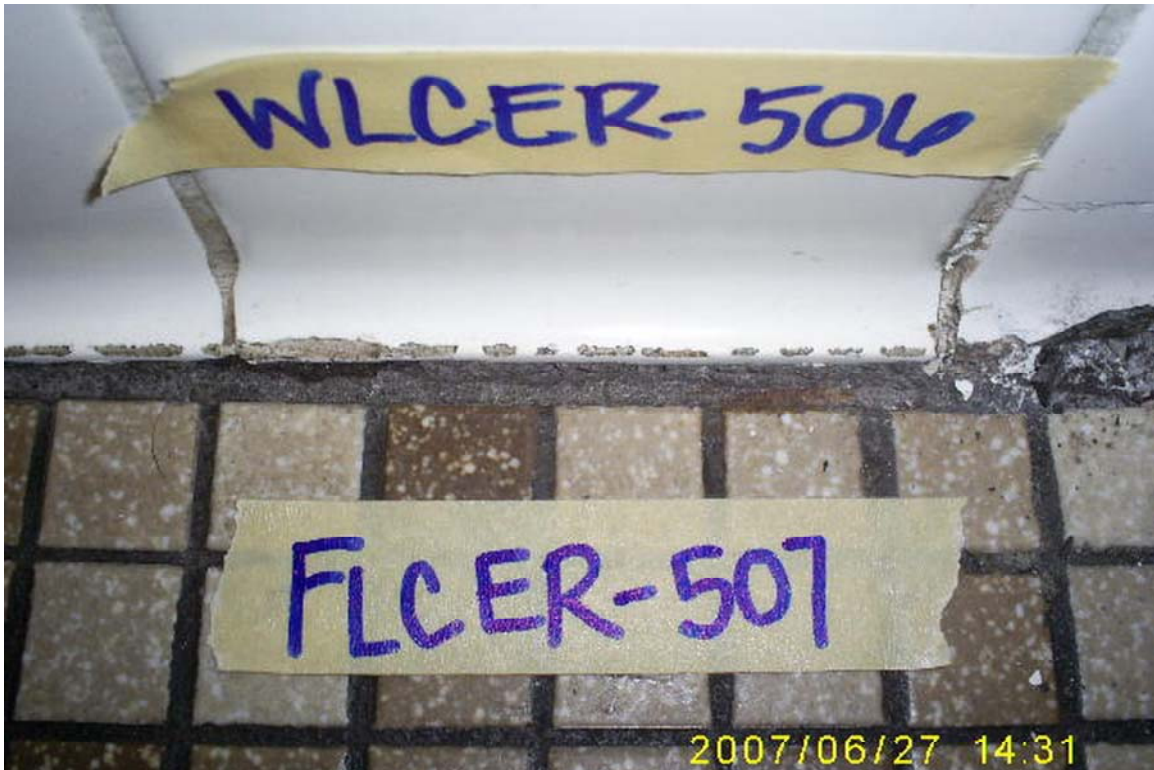
*Above: HA's WLCER-506 & FLCER-507*

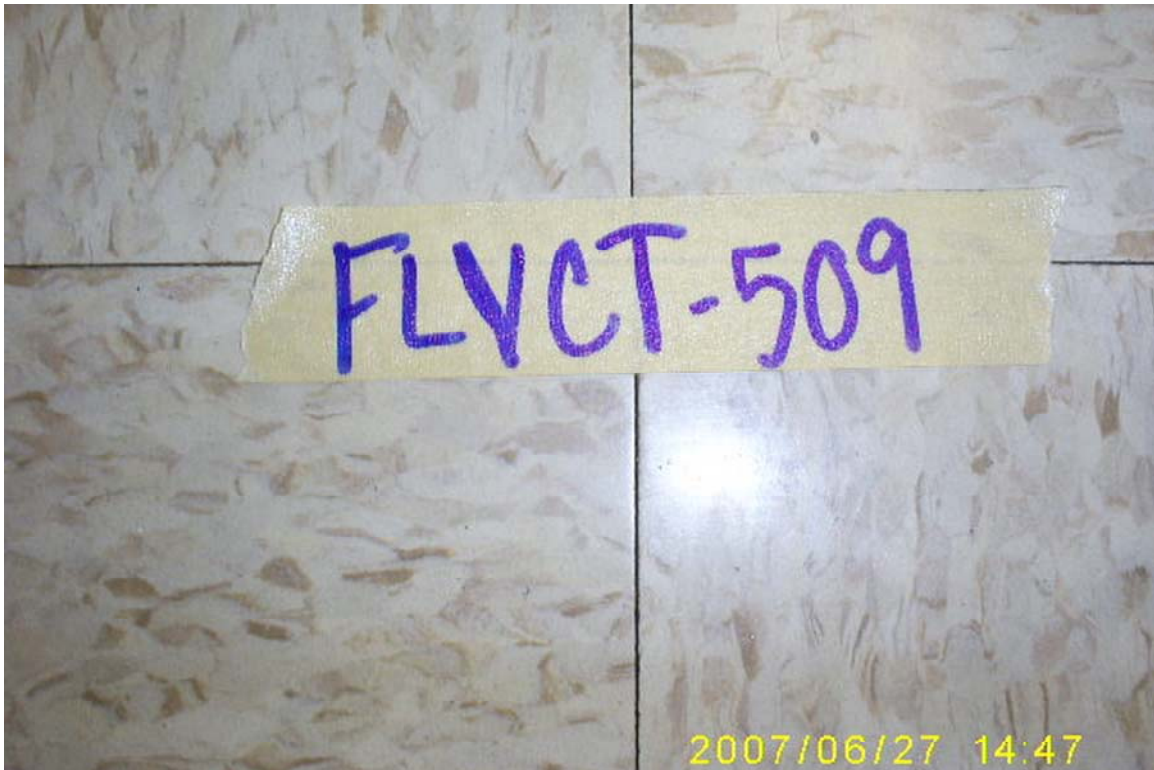
*Above: HA FLVCT-509*

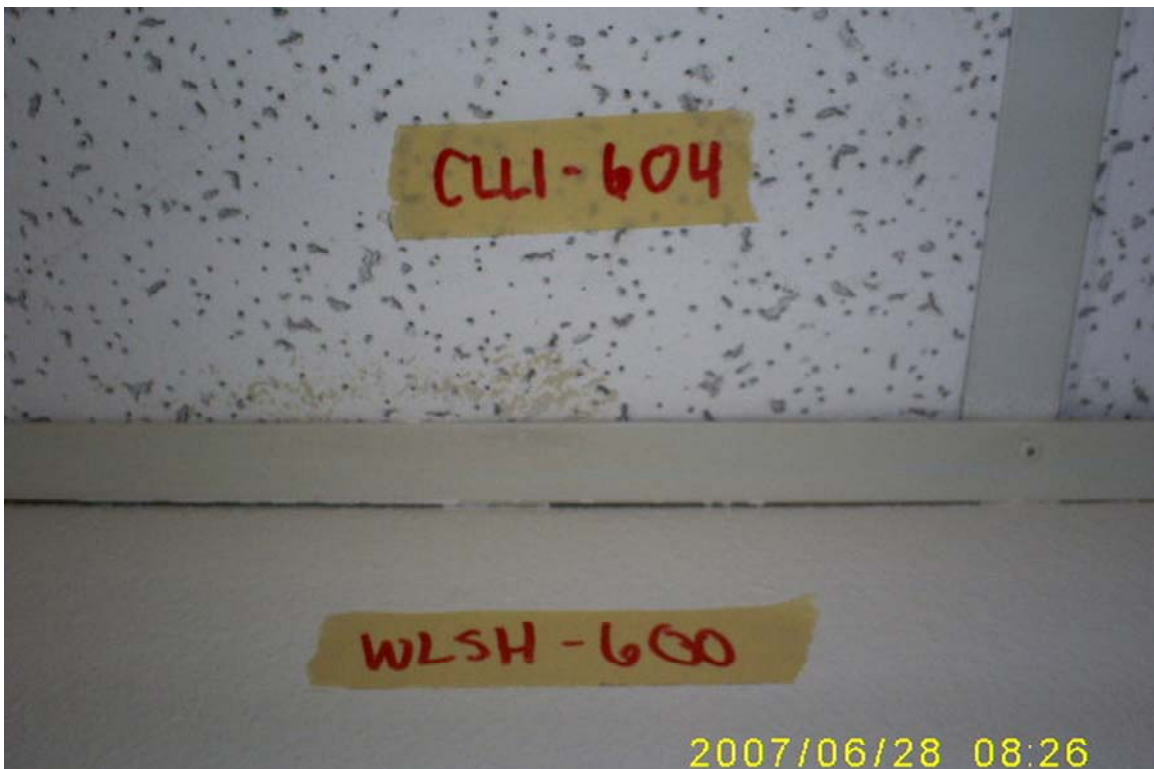
*Below: HA's WLSH-600 & CLLI-604*

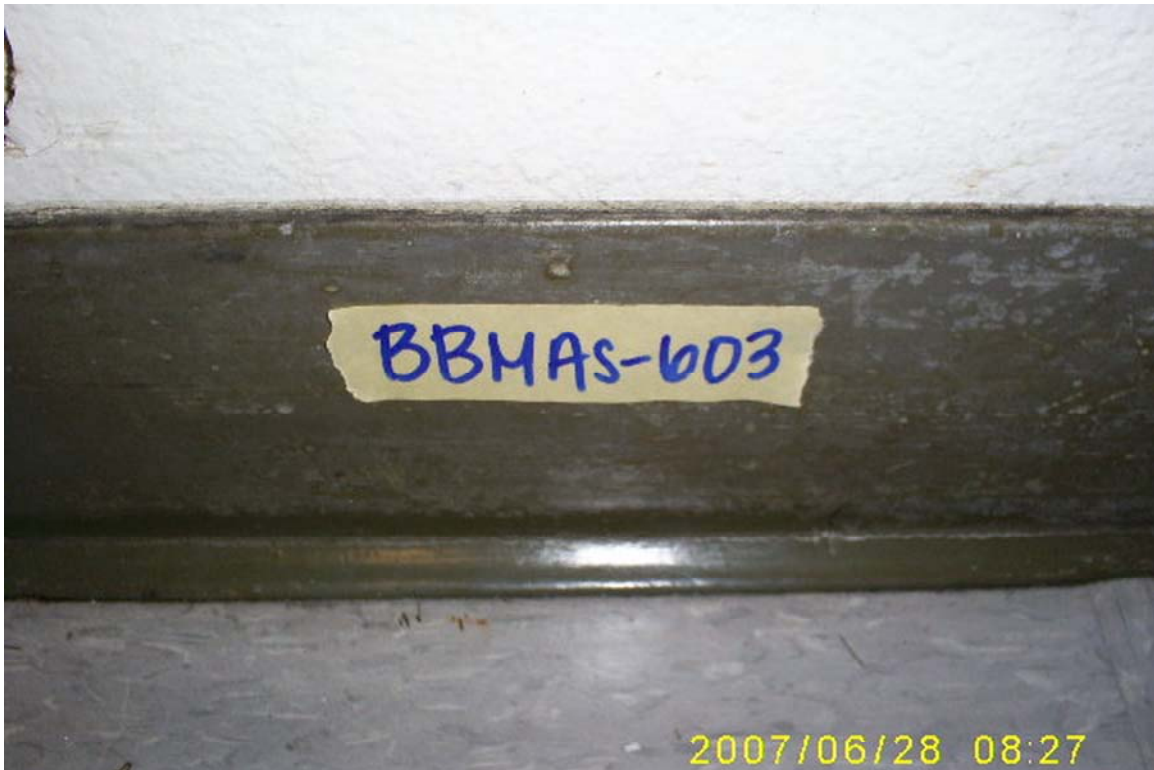
*Above: HA BBMAS-603*

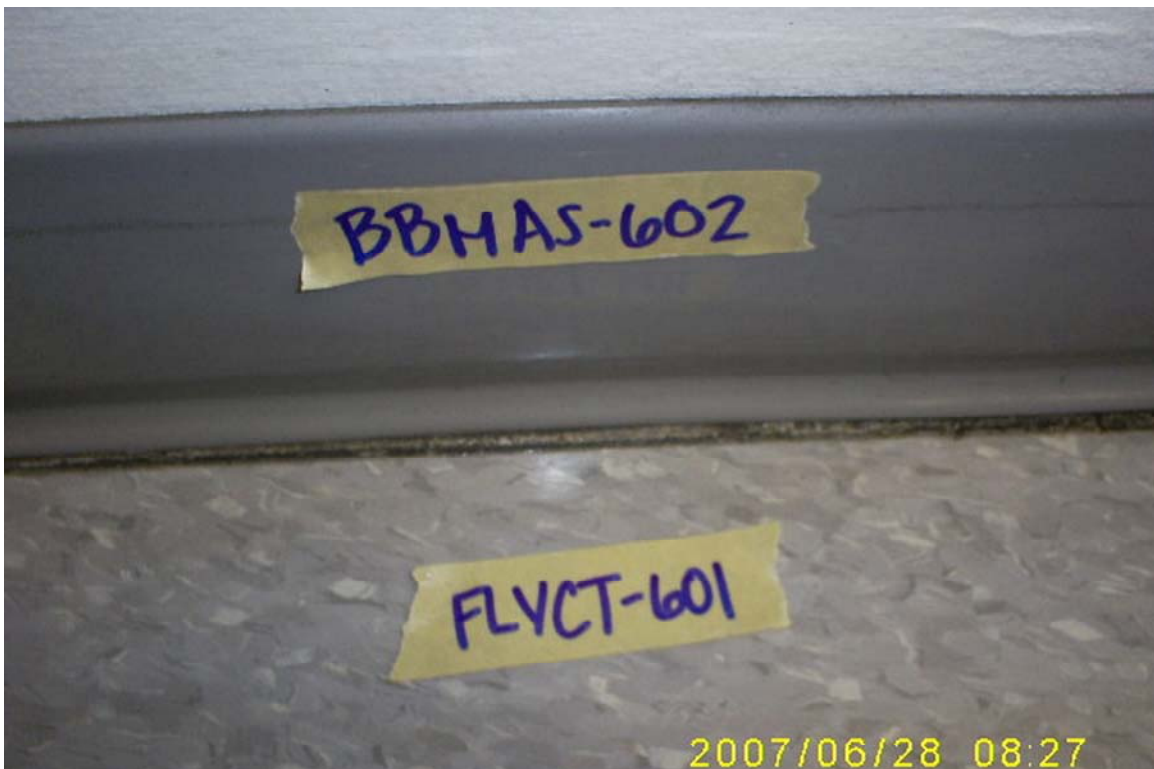
*Below: HA's FLVCT-601 & BBMAS-602*

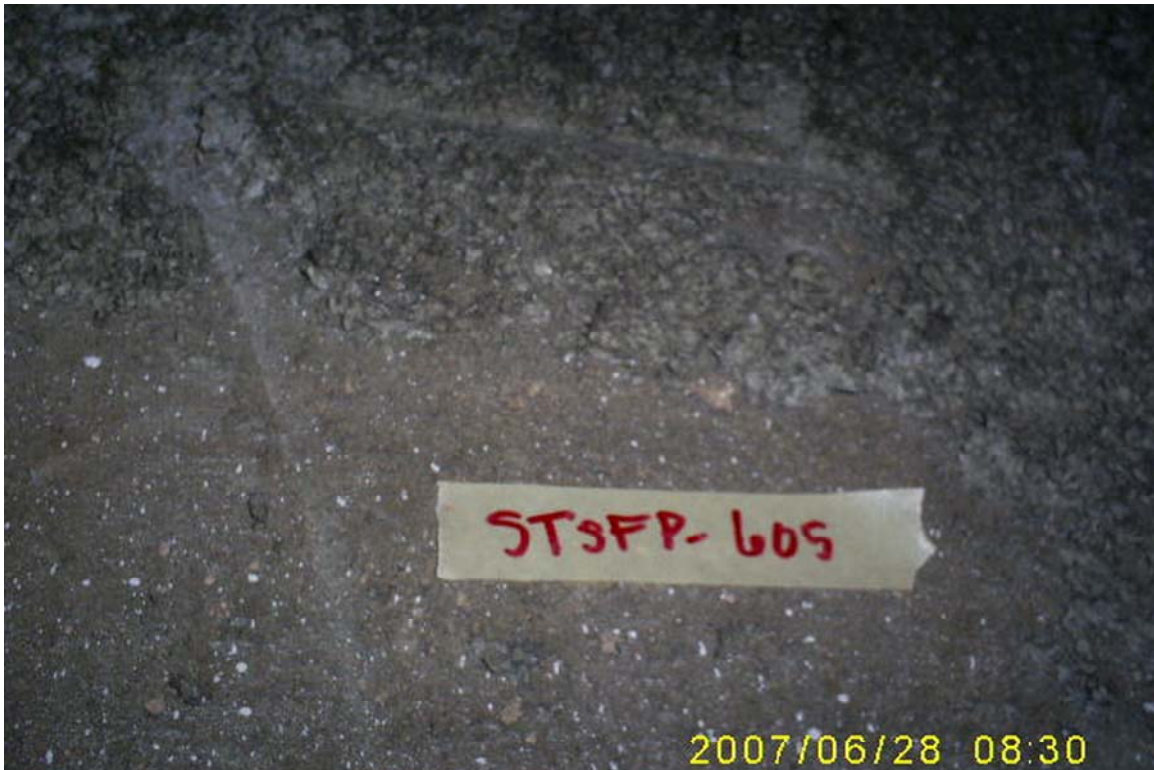
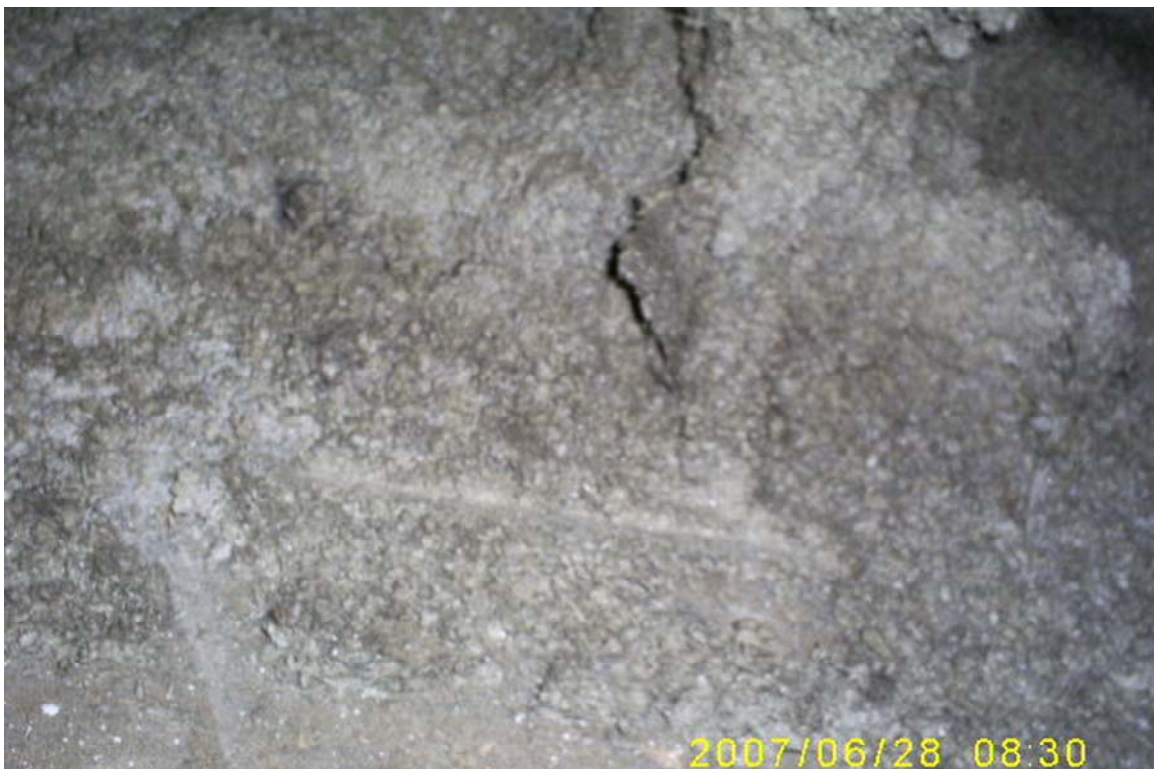
*Above & below: HA STSFP-605*

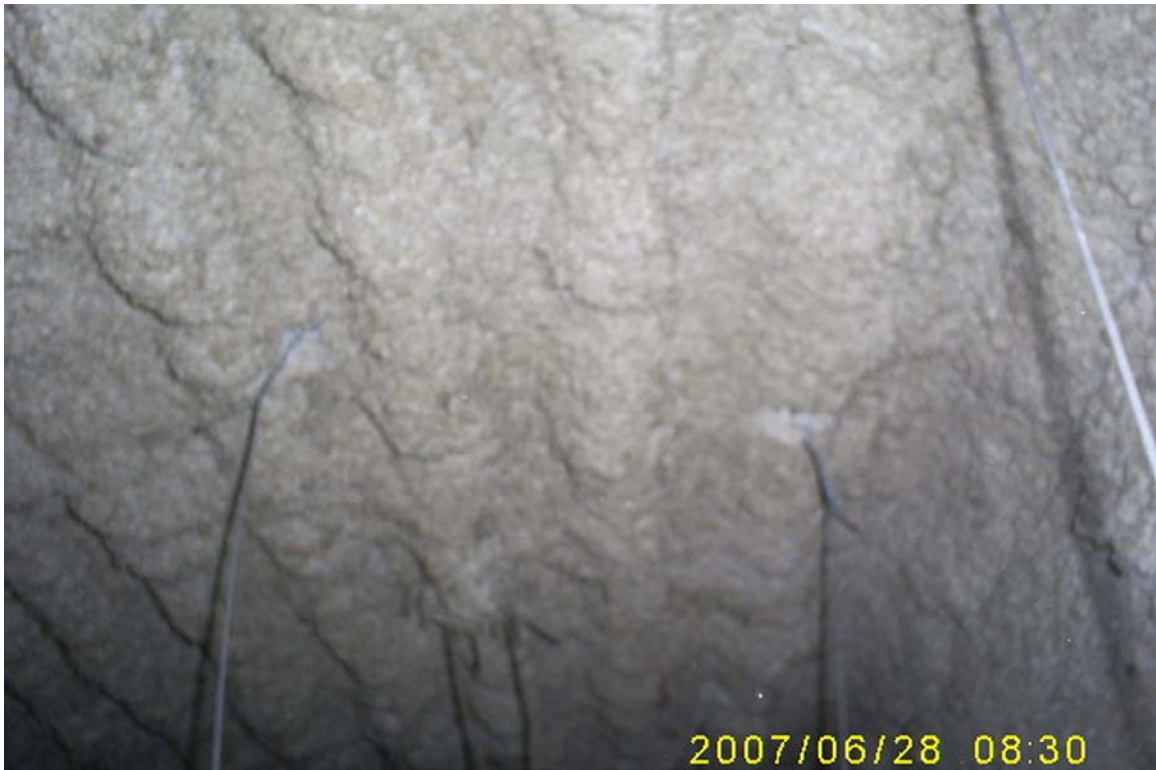
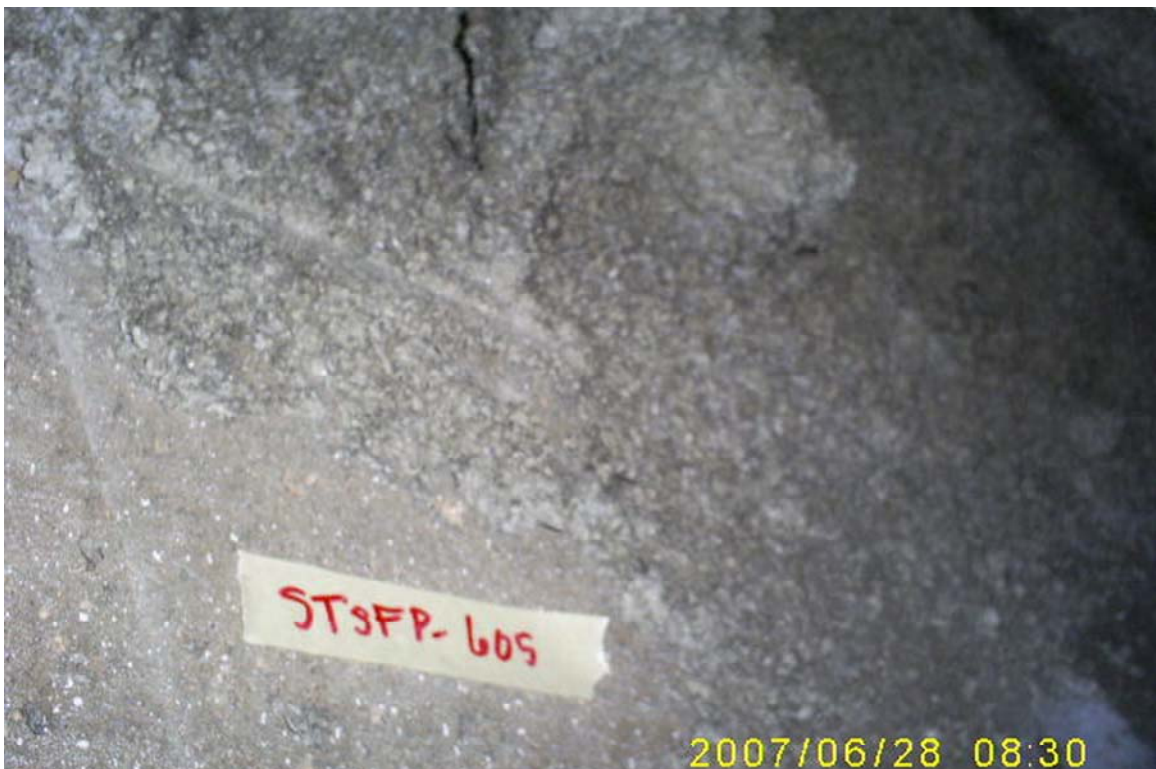
*Above & below: HA STSFP-605*
